FINAL REPORT
9438 HIGH LEVEL TRAVELING
WAVE TUBE AMPLIFIER *ANOMALY*

VOLUME I

Prepared by
J. A. Durschinger
TRW, Inc.
TRW Defense and Space Systems Group
One Space Park
Redondo Beach, CA 90278

11 August 1978

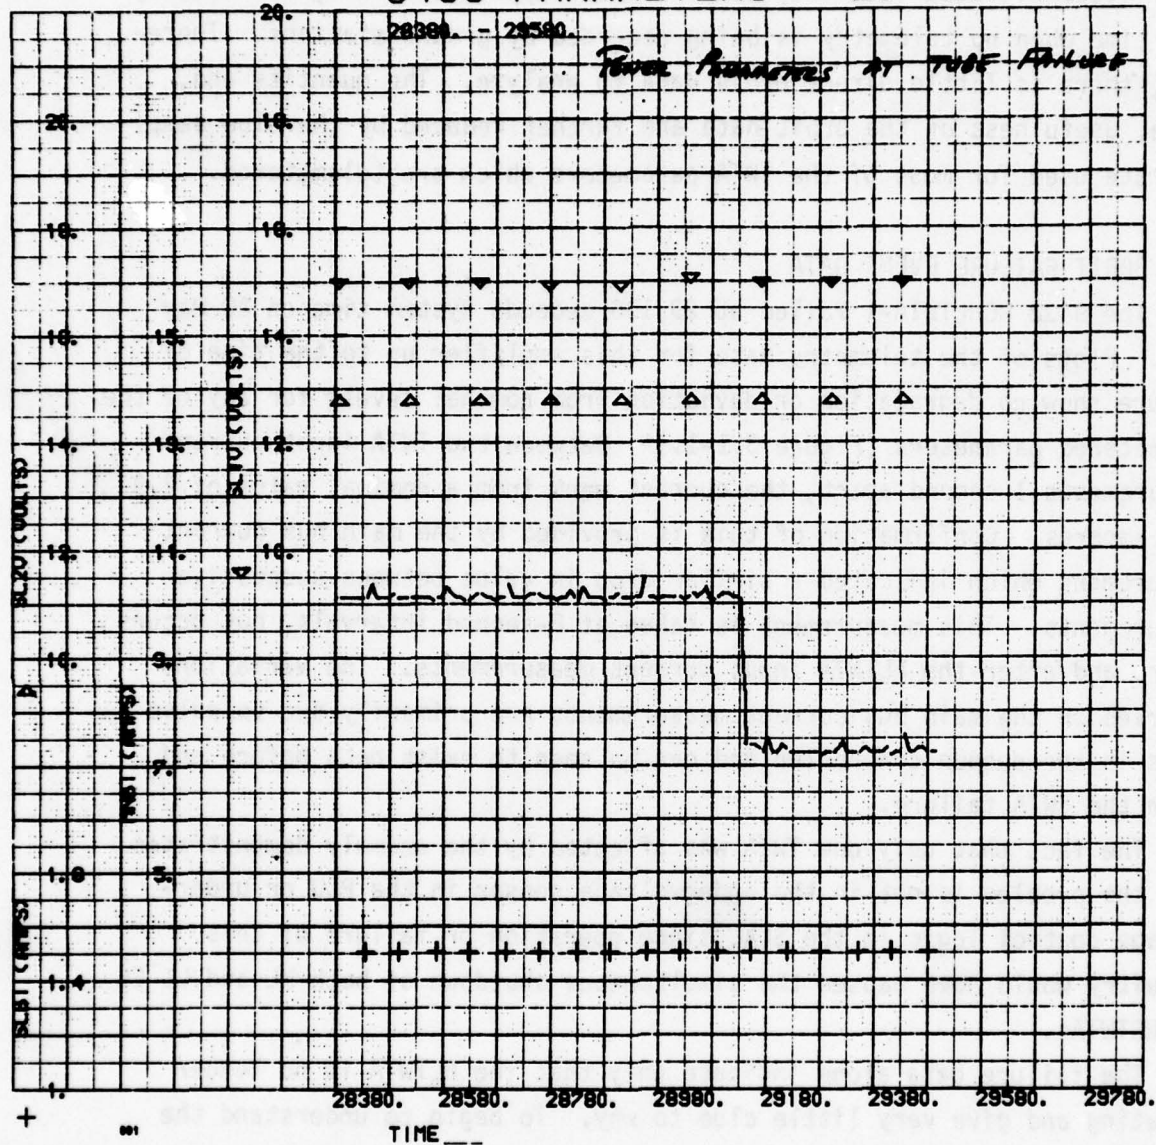
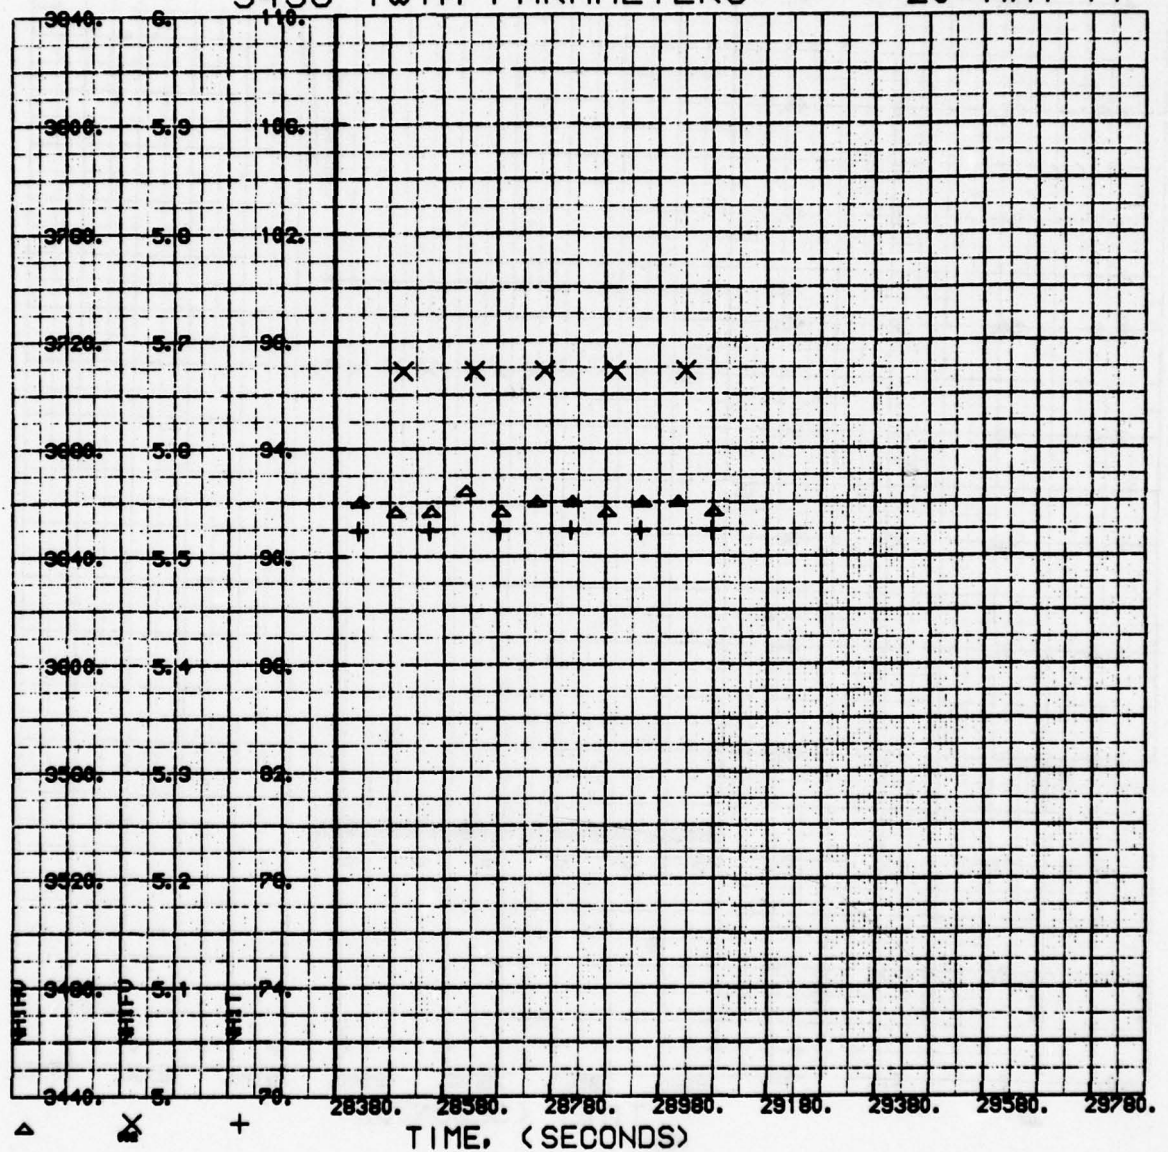
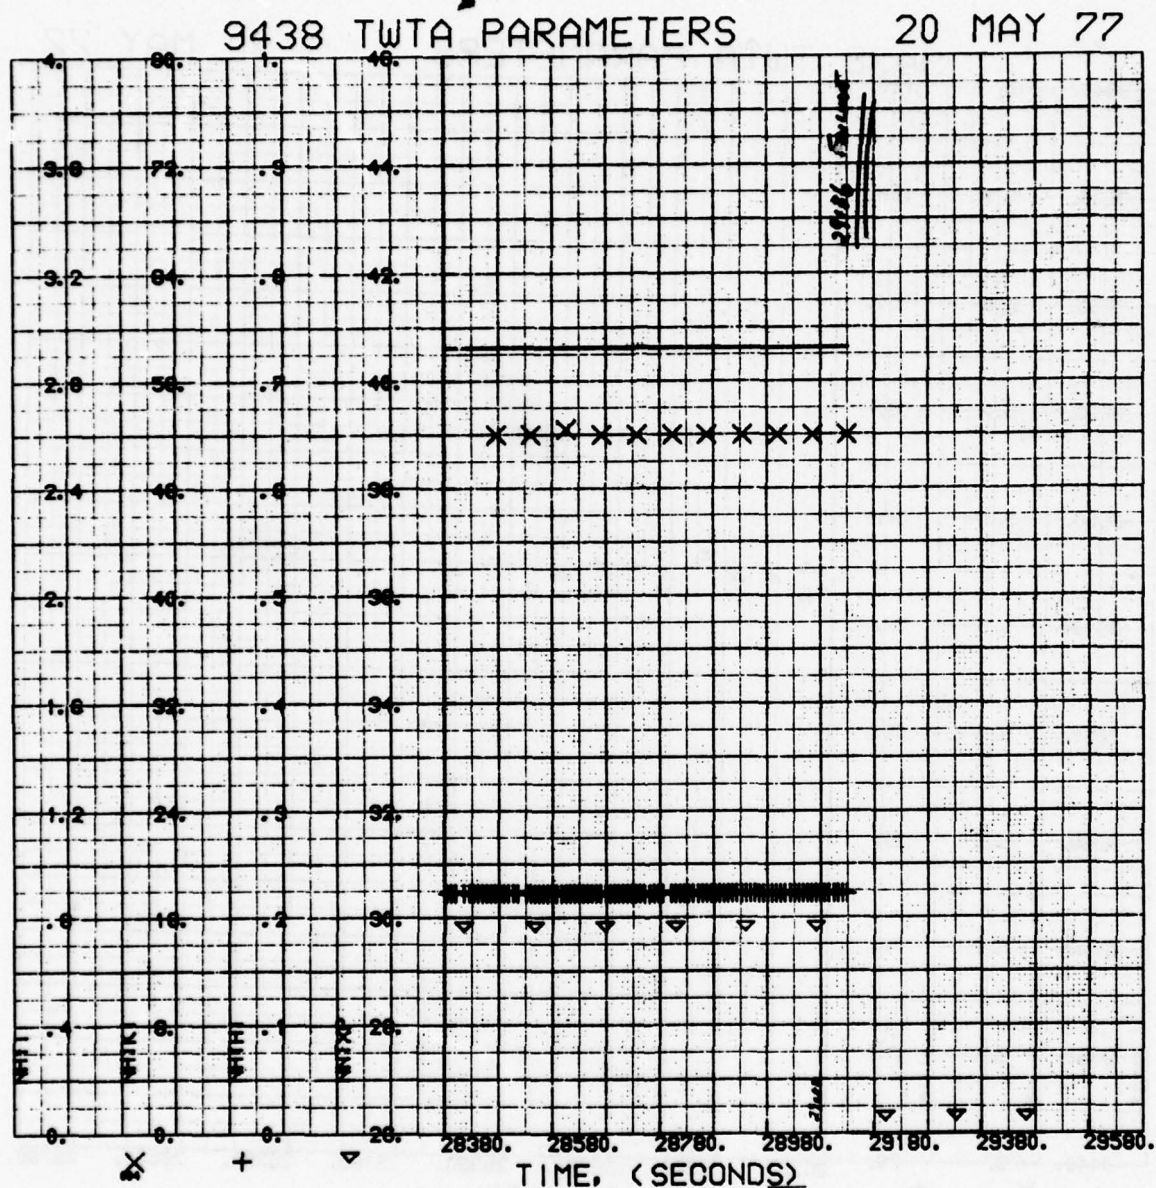
Figure 3.1-1. F8 HLTWA-1 Parameters at Time of Orbit Failure (20 May 1977)
Show Sudden Turn Off Without Warning

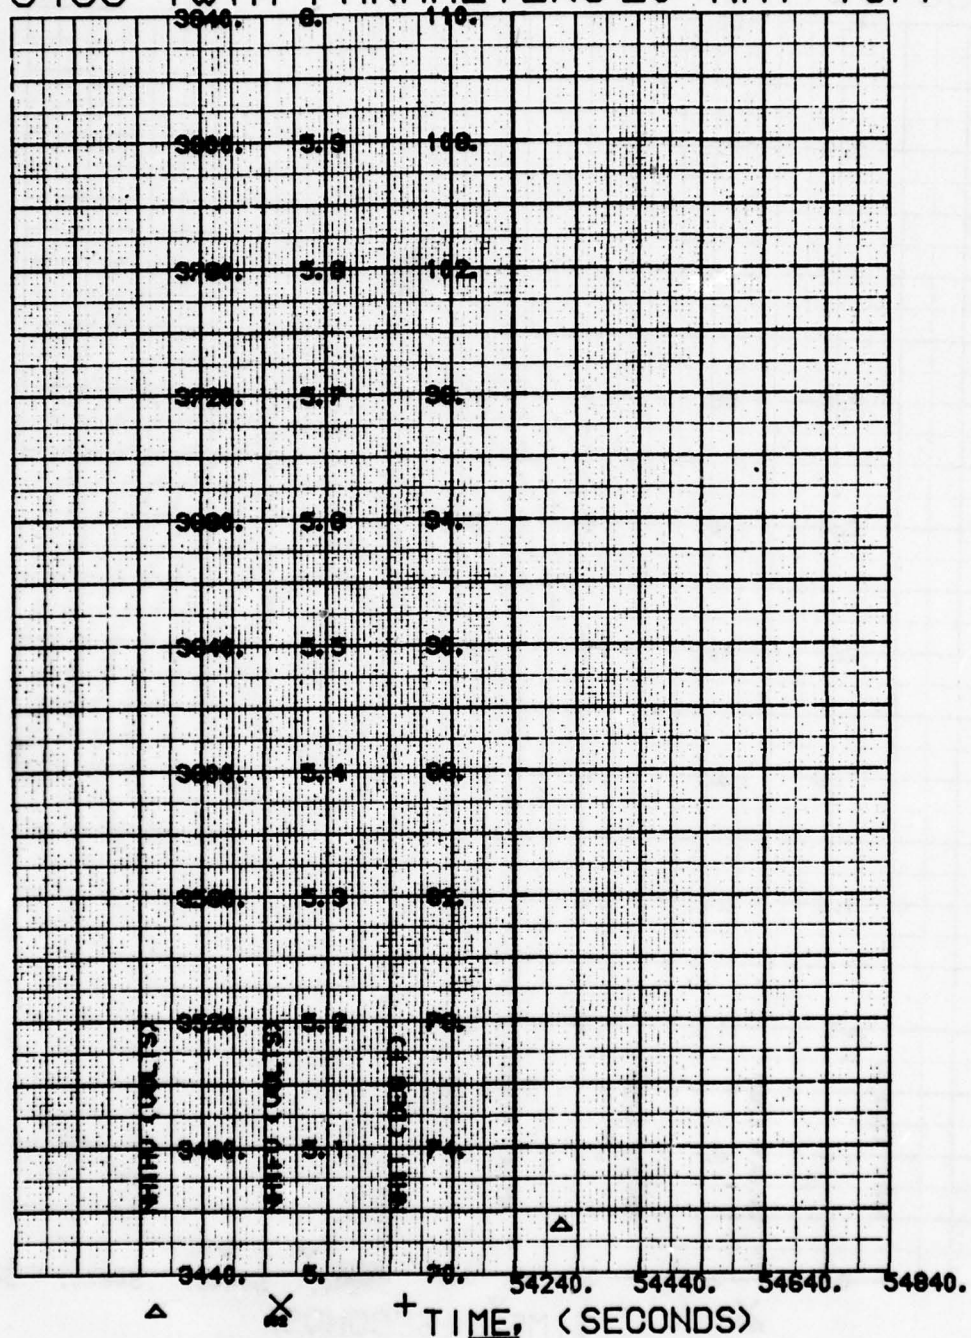
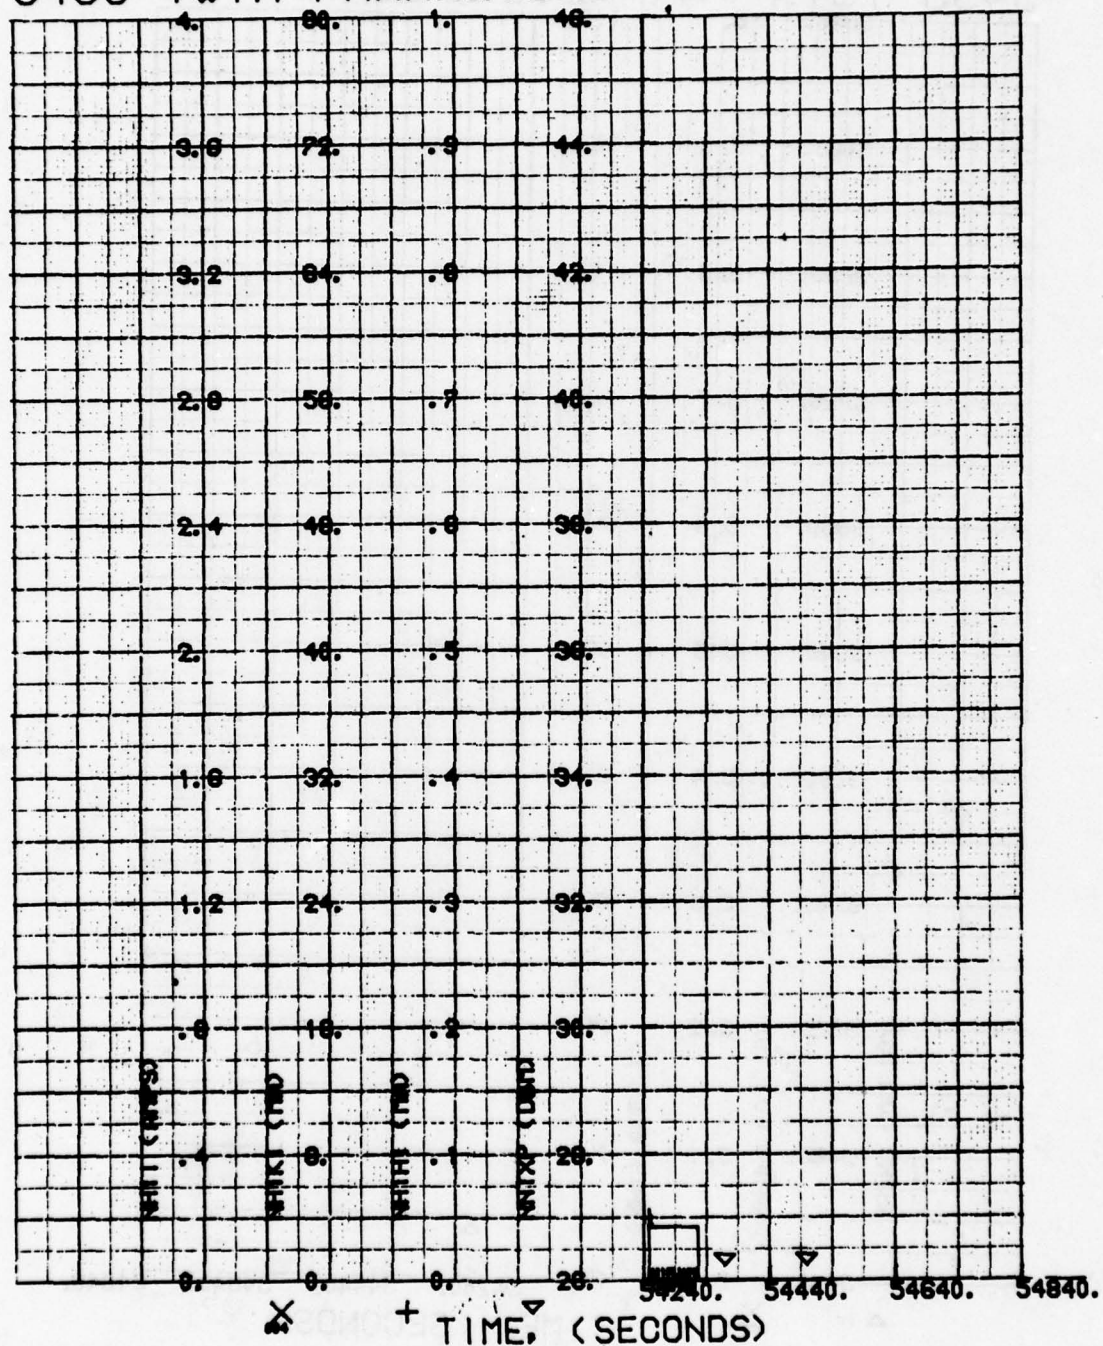
anomaly, it was necessary to attempt to turn the TWT on. This was first done approximately 25,000 seconds after the failure. At this turn-on attempt (Figure 3.1-2) and for all others attempted later (Appendix A-1), the HLTWTA response was similar: The power supply turned on and provided filament voltage to the TWT. After approximately 90 seconds, when the internal high voltage delay timer timed out, the amplifier immediately shut down. The high-voltage delay timer is designed for a nominal time delay between initial turn-on and application of high voltages to the TWT of 90 seconds. A review of the initial turn-on of this TWT in orbit showed this time delay had not changed from previous operation (Figure 3.1-3). A total of 11 turn-on attempts were made on 20 and 21 May 1977, all with the same result.

Figure 3.1-2. F8 HLTWTA-1 Parameters at First Turn On Attempt Show Nominal Operation Until the Instant of Application of High Voltage (The Amplifier Shutdown Immediately Thereafter) (Continued)

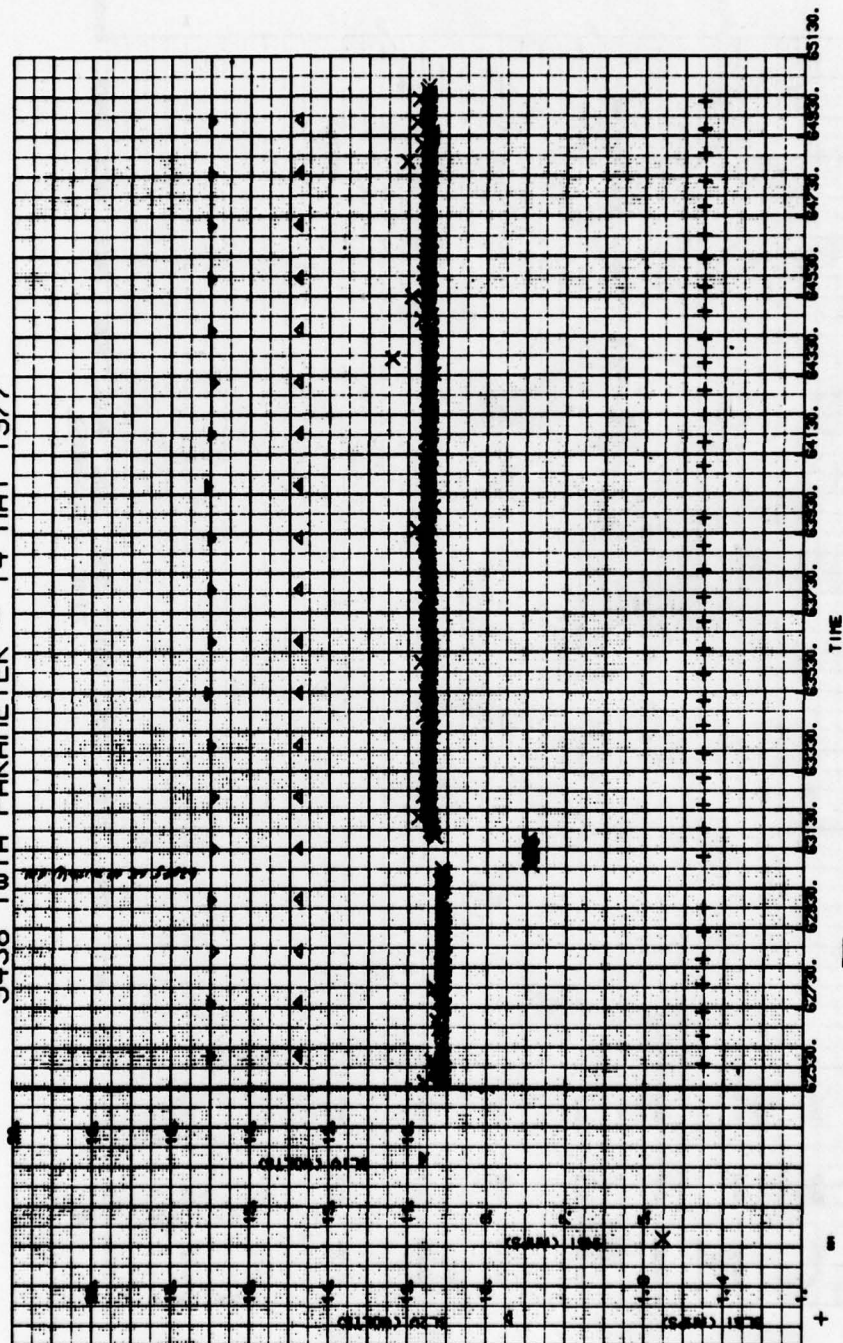
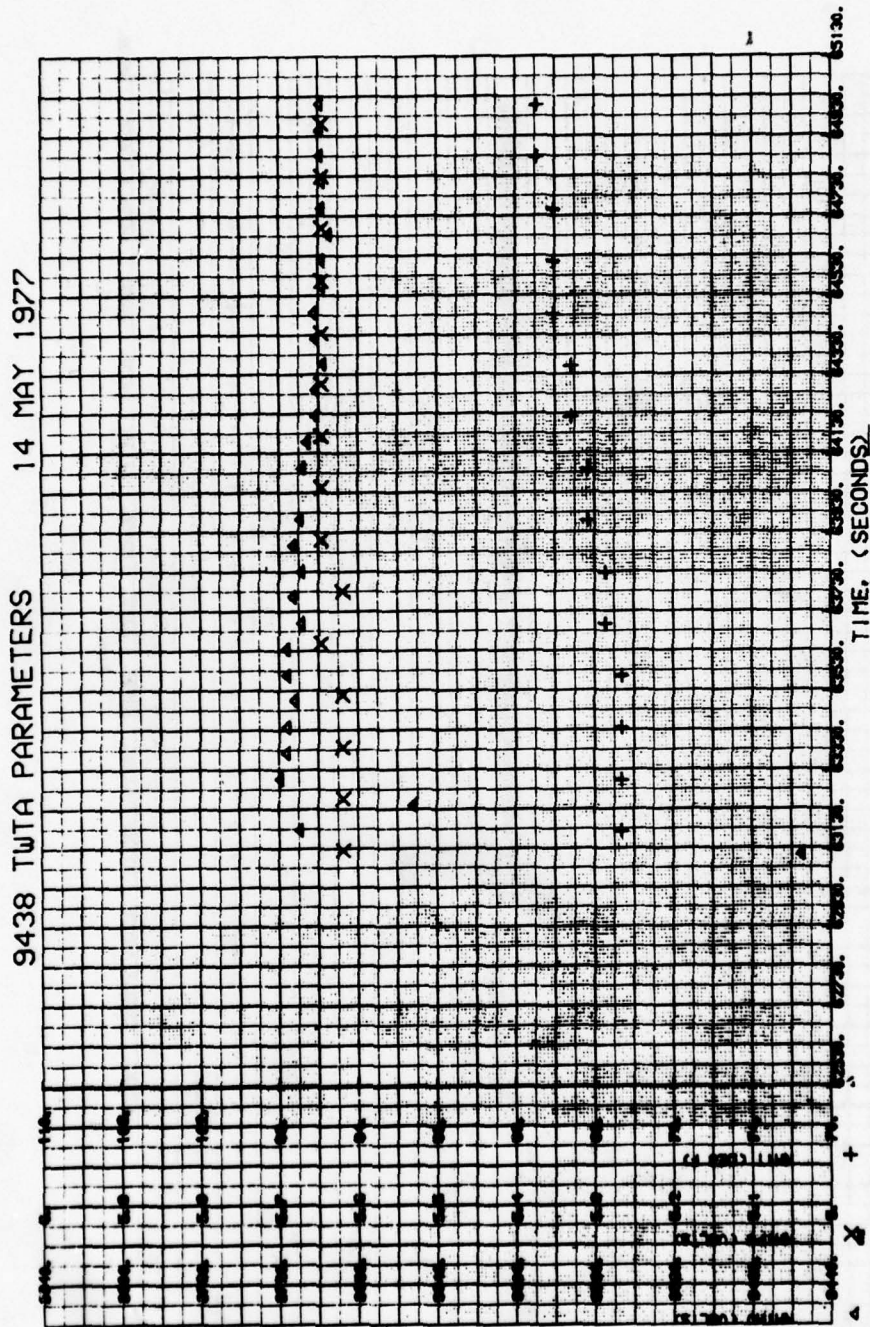
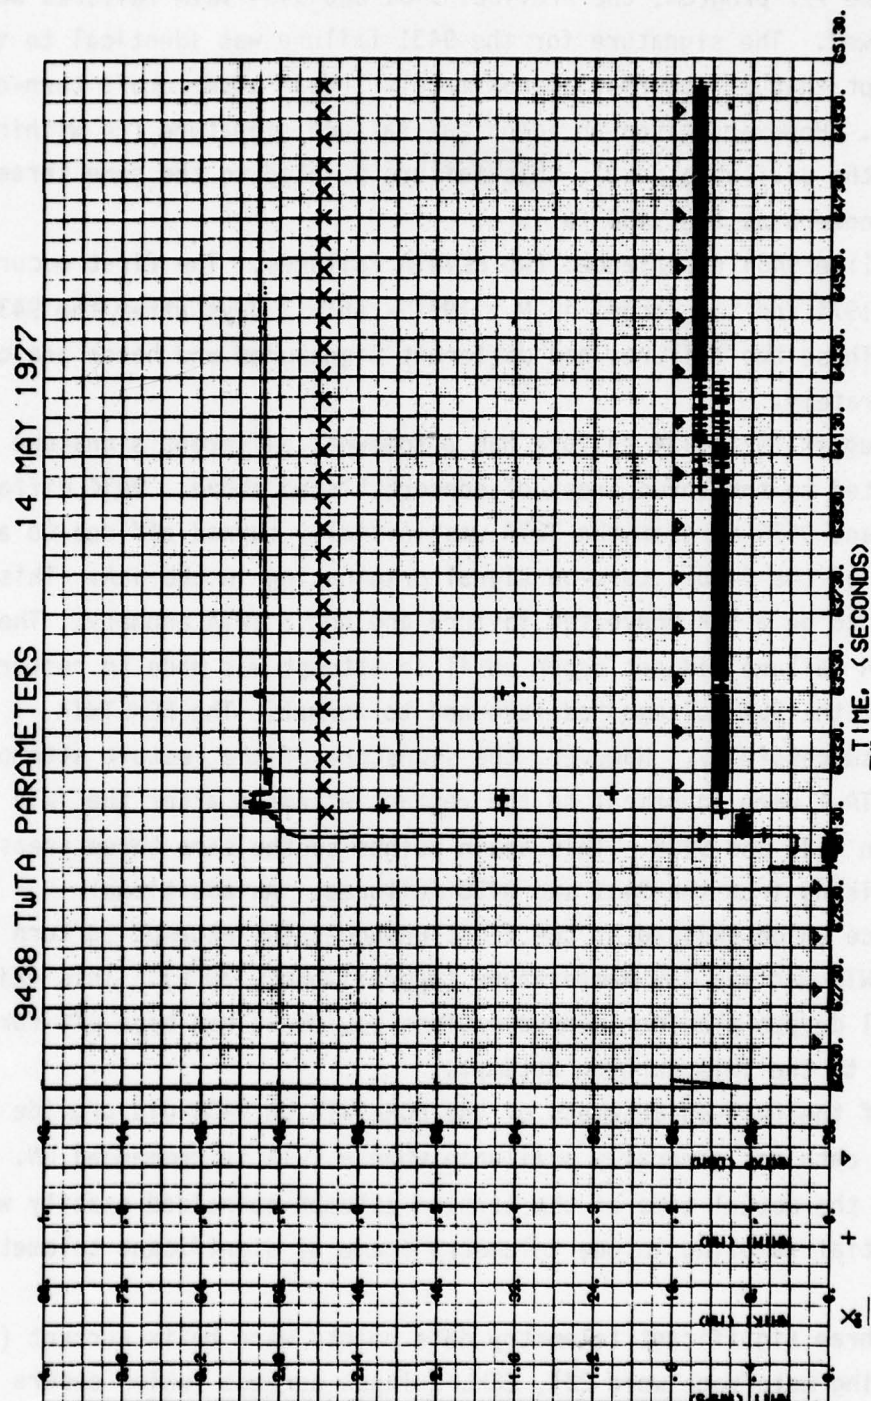
Figure 3.1-3. F8 HLTWTA-1 Initial Orbit Turn On Data Shows Nominal Operation of High Voltage Timer Followed by Successful Application of High Voltages to TWT

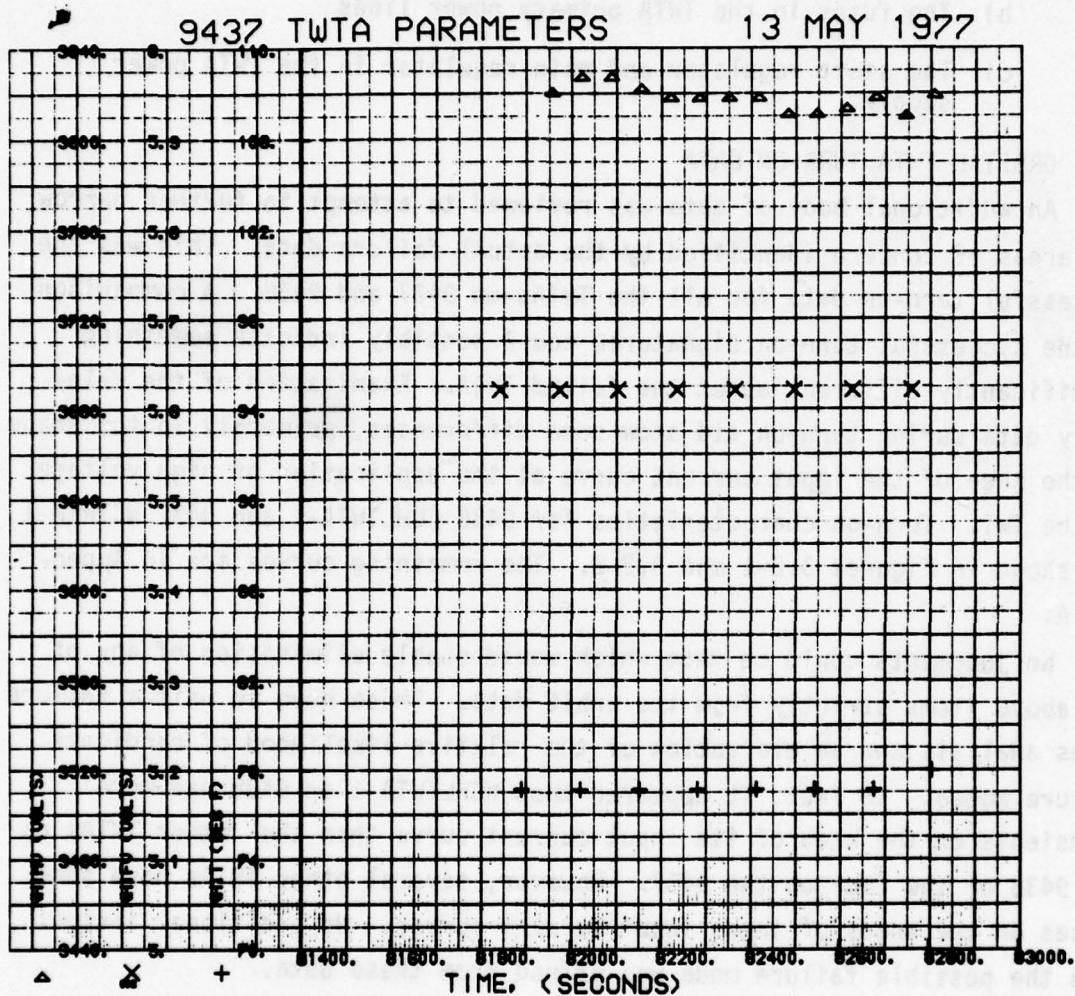
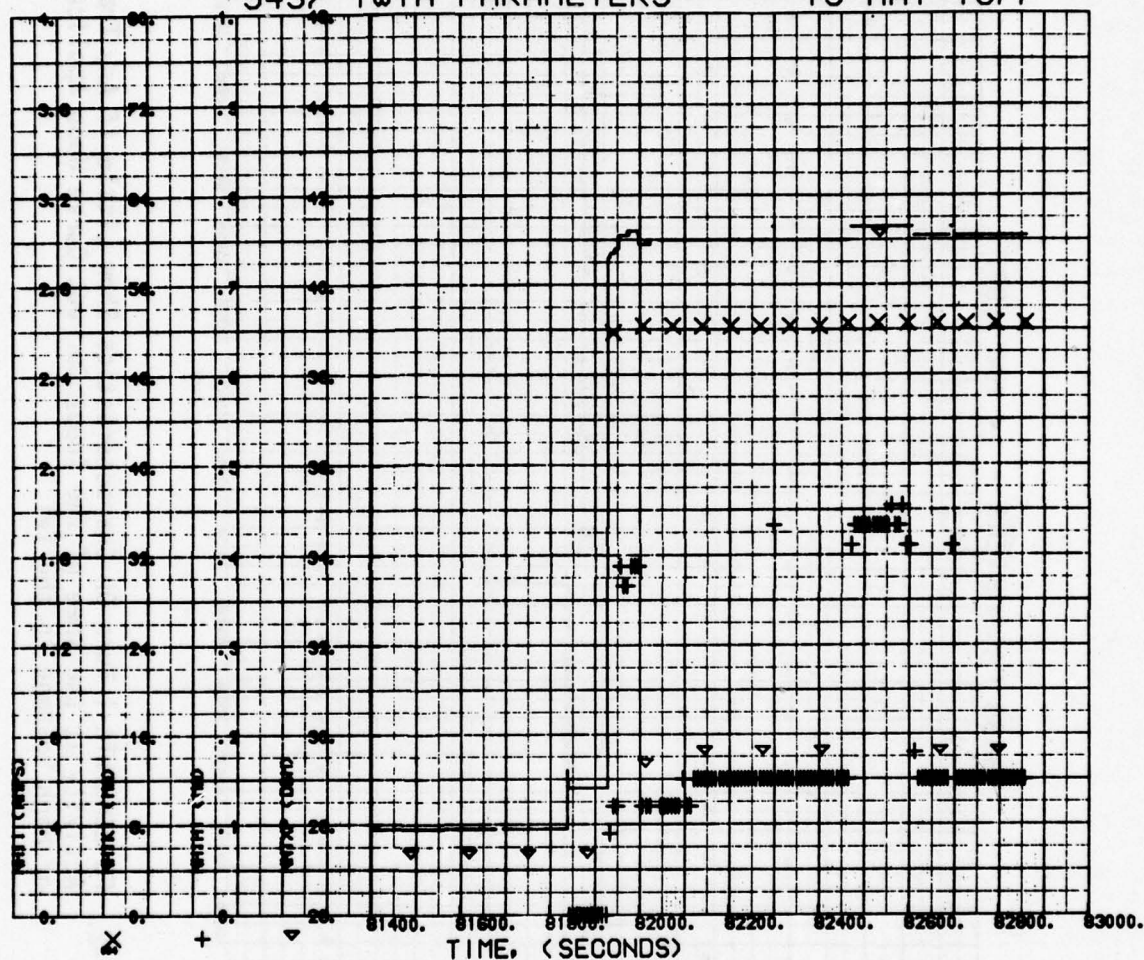
Although the 9438 TWTAs failure appeared to occur without warning, there were transients on the input current at application of high voltage in orbit, which was not what would be normally expected. Therefore, a study was performed of the ground test data for all eight HLTWTAs in payload 4 (9437 and 9438 satellites) to see if there was an historical difference in this characteristic for the failed TWTAs. This study included review of all steady-state operating data as well as ground test turn-on data.

Figure 3.2-1. F7 NCHLTWTA-1 Turn On Characteristics
Show Some Input Current Transients
Upon Application of High Voltage

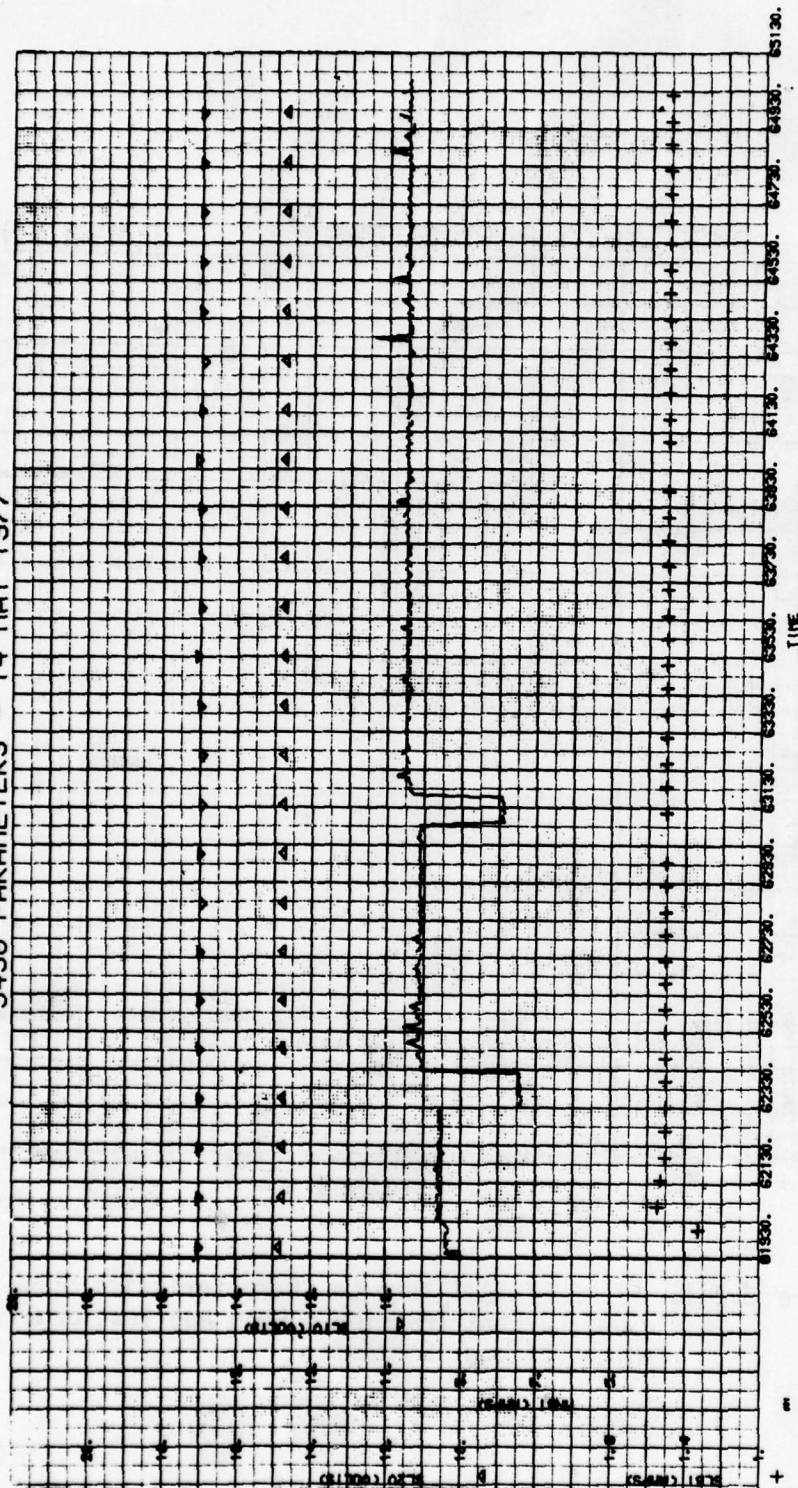
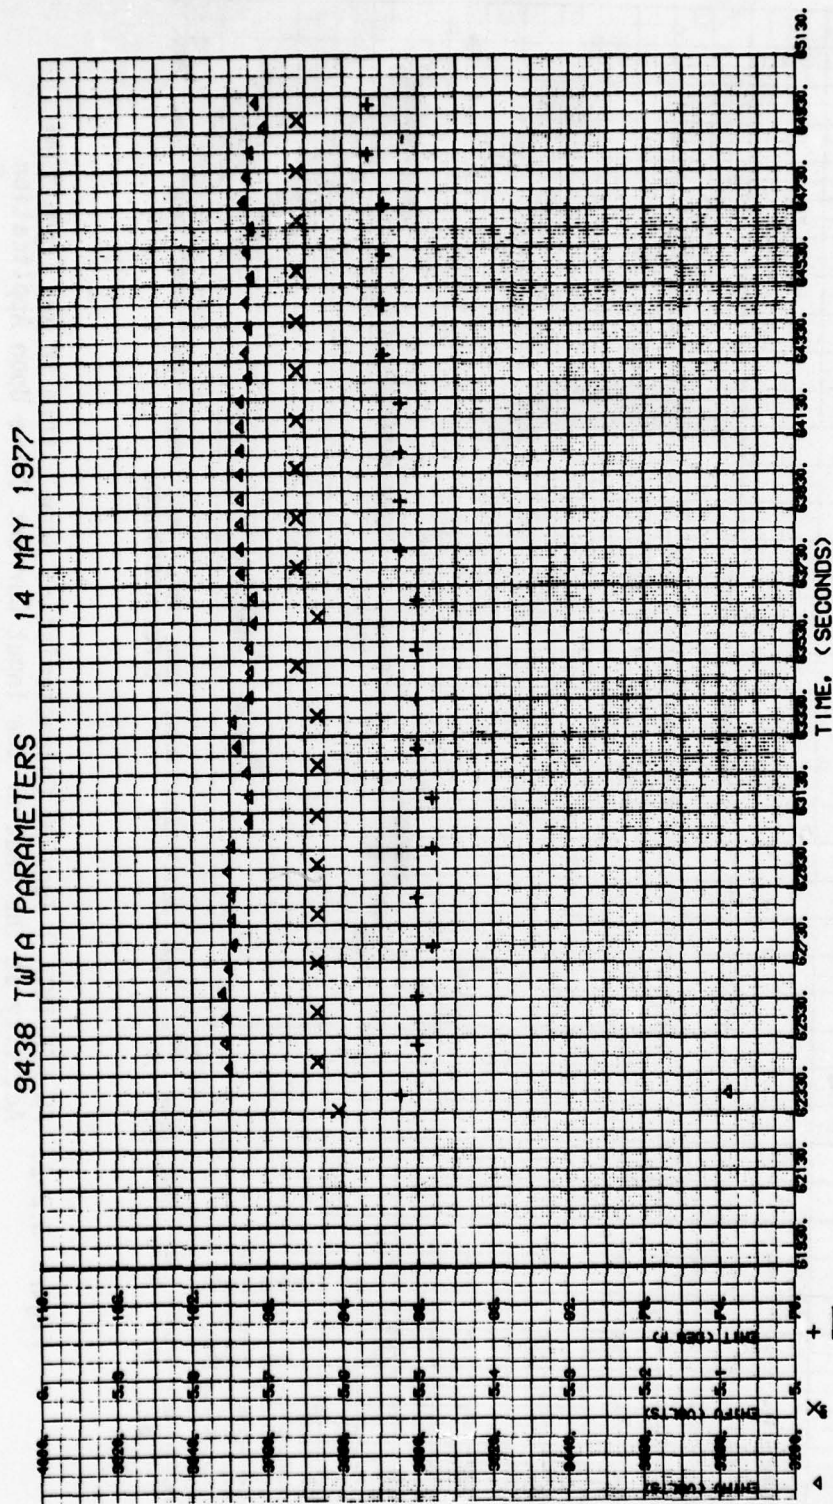
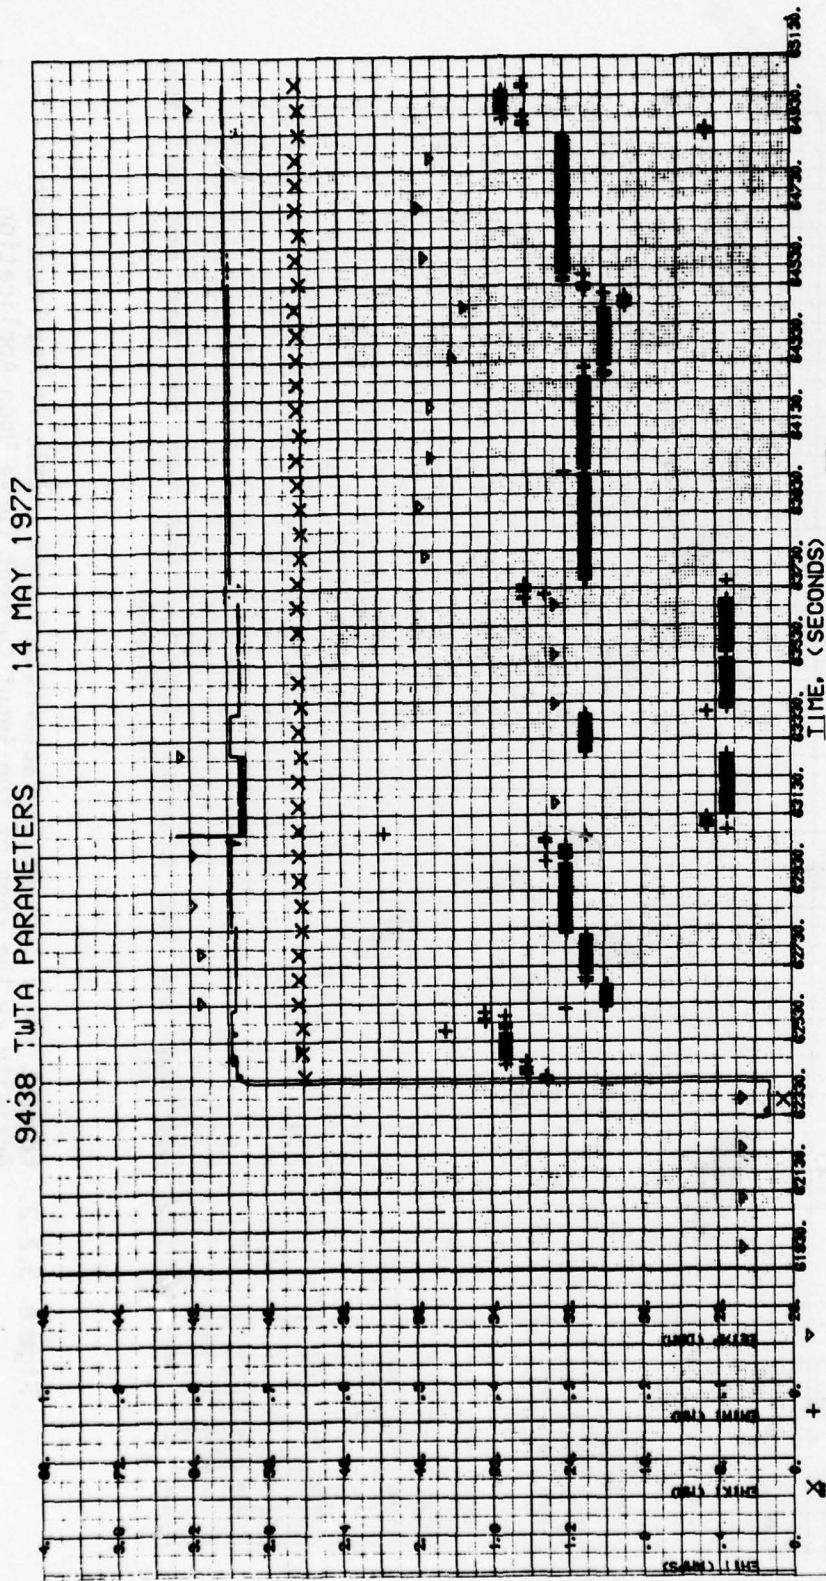
Figure 3.2-2. F8 ECHL TWT-1 Turn On Characteristics Show Little if Any Transients Activity at the Knee of the Input Current Curve Upon Application of High Voltage to the TWT

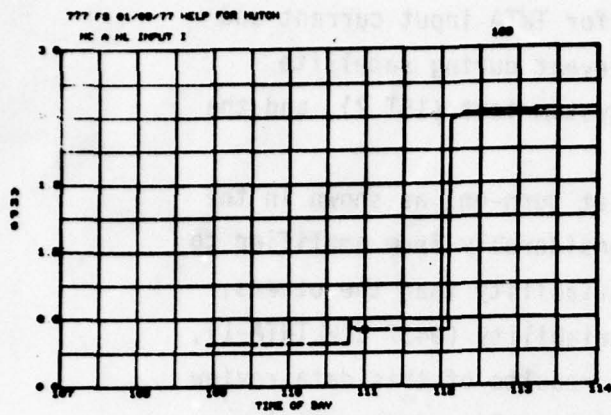
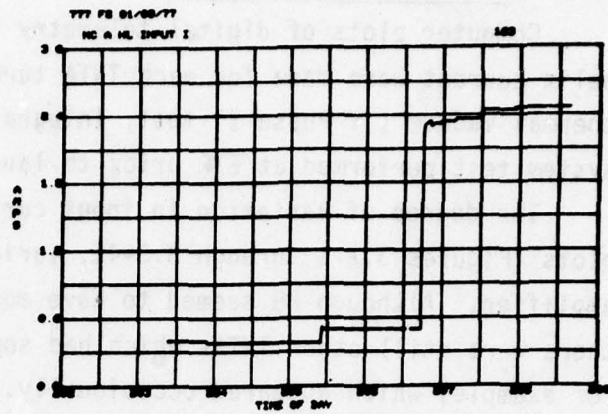
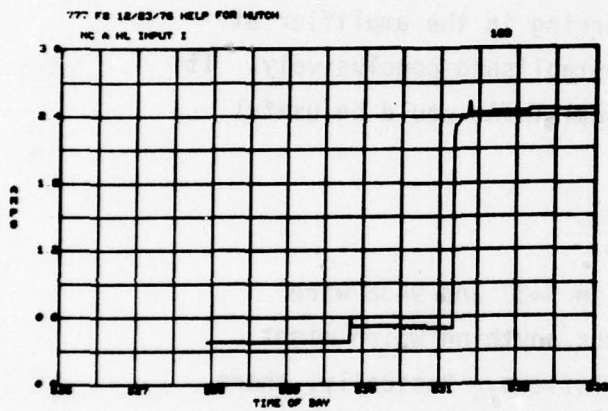
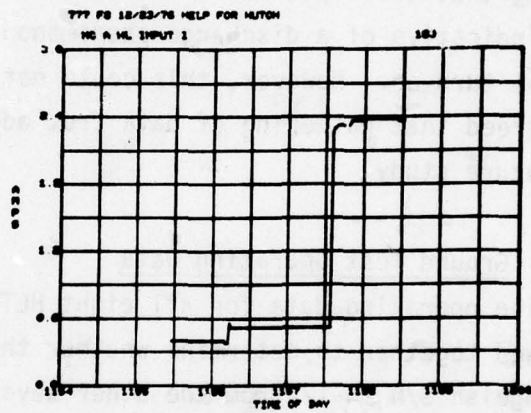
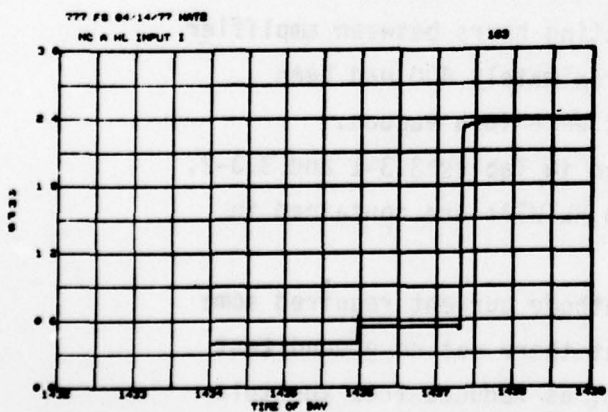
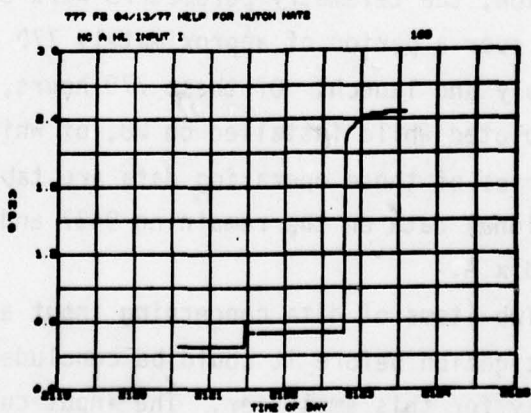
Figure 3.3-1. F8 NCHLTWTA-1 Input Current Turn On Characteristics Show Intermittent Transient Activity During Some Turn On Events

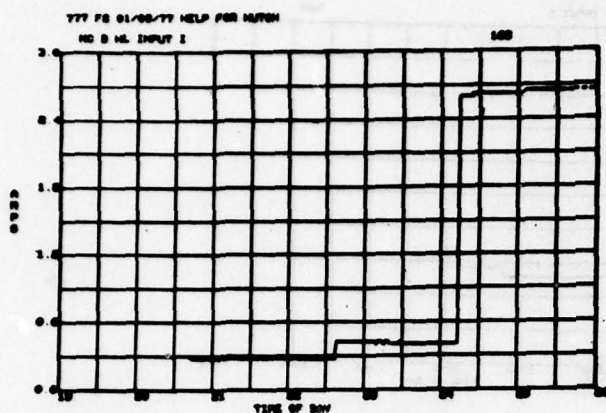
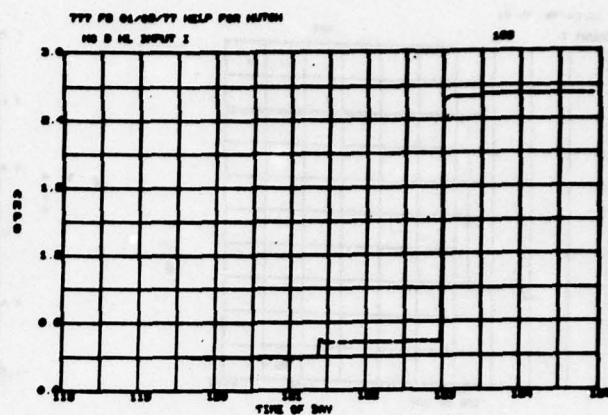
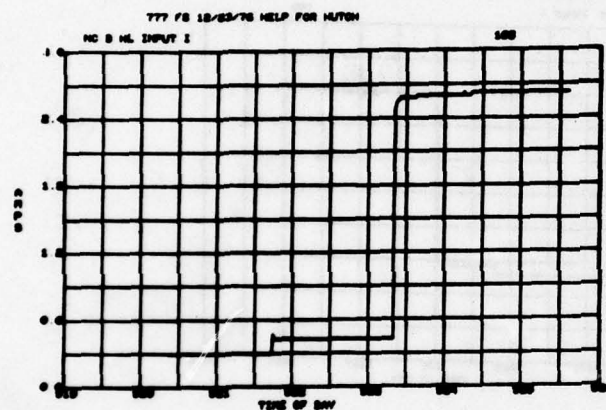
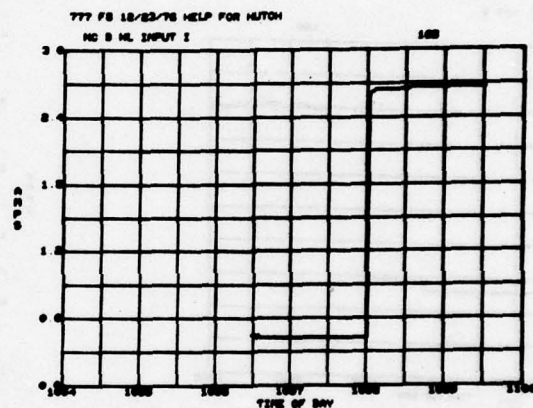
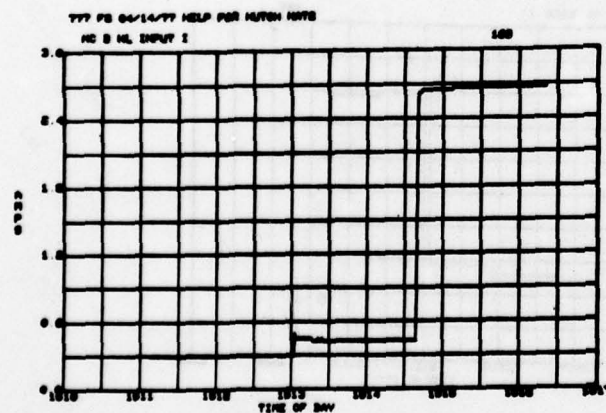
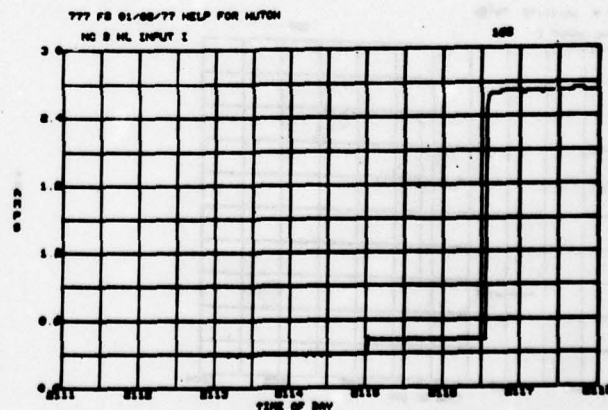
Figure 3.3-2. F8 NCHLTWTA-2 Input Current Turn On Characteristics Show Little Variation Between Successive Test Startups

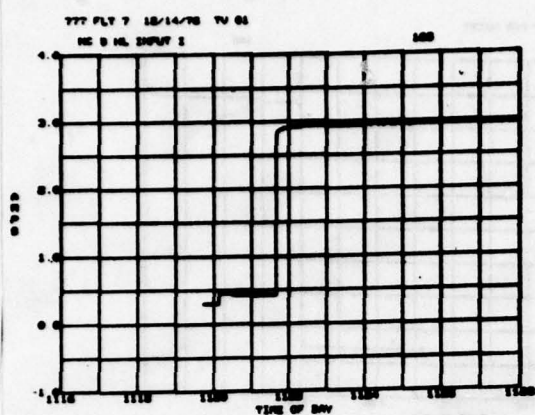
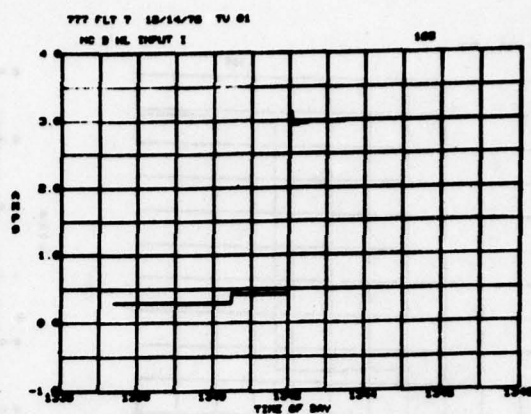
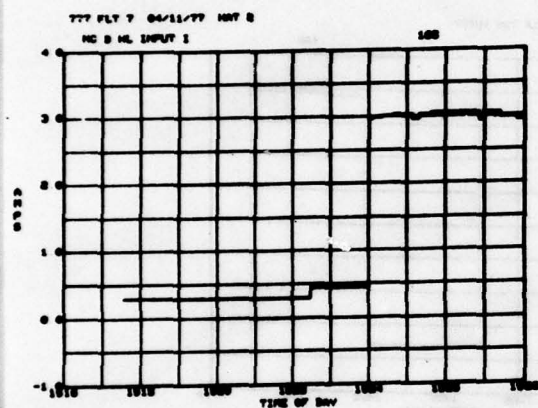
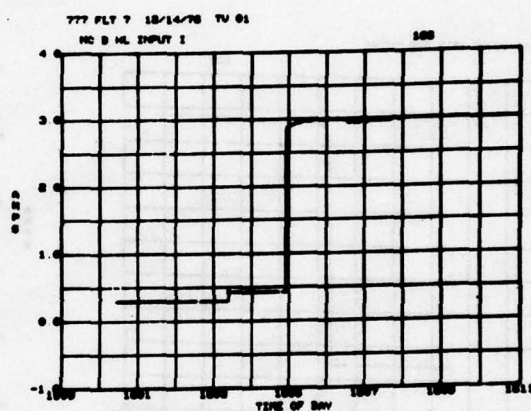
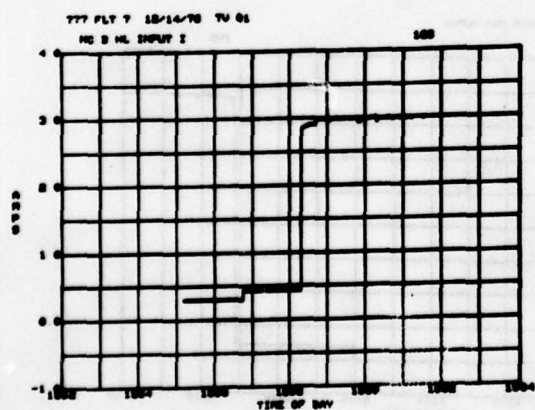
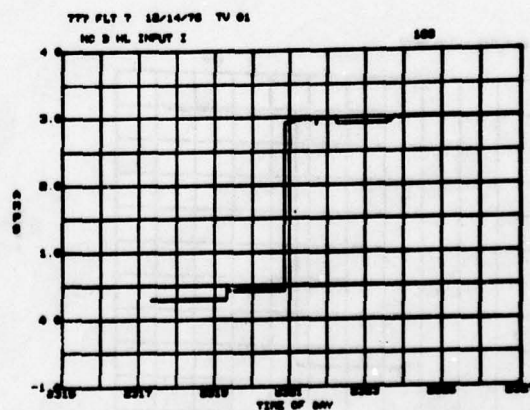
Figure 3.3-3. F7 NCHLTWTA-2 Input Current Characteristics Show Some Variation in Transient Content Between Successive Starts

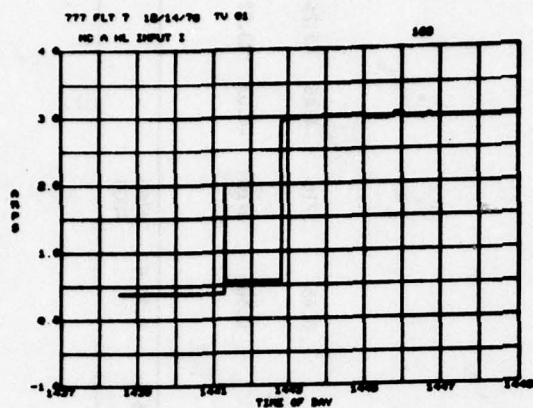
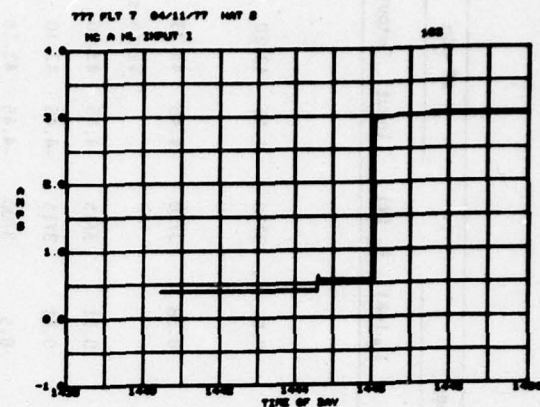
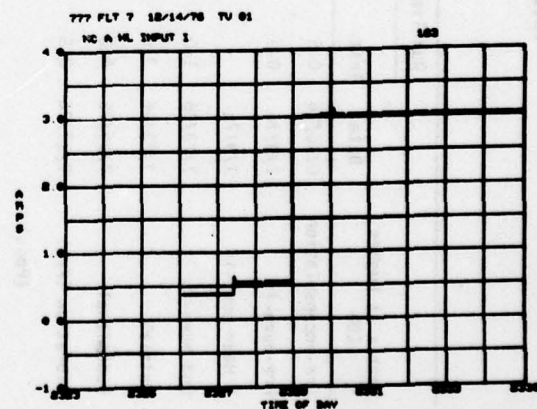
Figure 3.3-4. F7 NCHLTWTA-1 Input Current Characteristics Show Little Variation Between Successive Starts
